ROCKVILLE TRUSS BRIDGE REHABILITATION FEASIBILITY STUDY

Performed by Michael Baker International

For the Town of Rockville, Utah

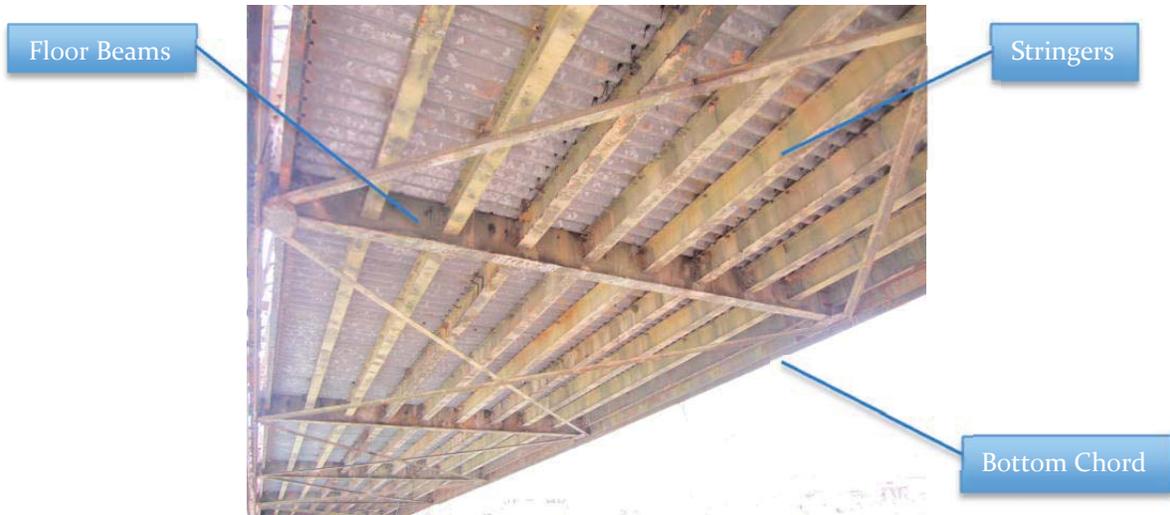
FIGURE 1 - DECK SYSTEM COMPONENTS

The analysis verified the current posting of 14 tons and identified the specific components that are limiting the loading. The limiting components are the stringers along the underside of the deck, the floor beams, and the diagonal chords in the first and last interior truss panels. To obtain an acceptable load rating, these members will need to be strengthened. See Figures 1 and 2 for identification of these members.

In order to meet a load posting limit of 25 tons, the limiting members will have to be strengthened. See Figures 1 and 2 for visual representations. The following is a list of the limiting members and the recommended actions:

All of these beams will need to be replaced with stronger beams. The total number of stringers is 110. The contractor will need to stagger the removal so that the floorbeams and trusses do not deform. The corrugated steel and asphalt decking will need to be removed to perform the work.

The interior floor beams will need to be strengthened. There are 9 interior floor beams. This can be accomplished by bolting cover plates to the bottom of the beams. Bolting is the preferred method of attachment instead of welding which is prone to fatigue issues.

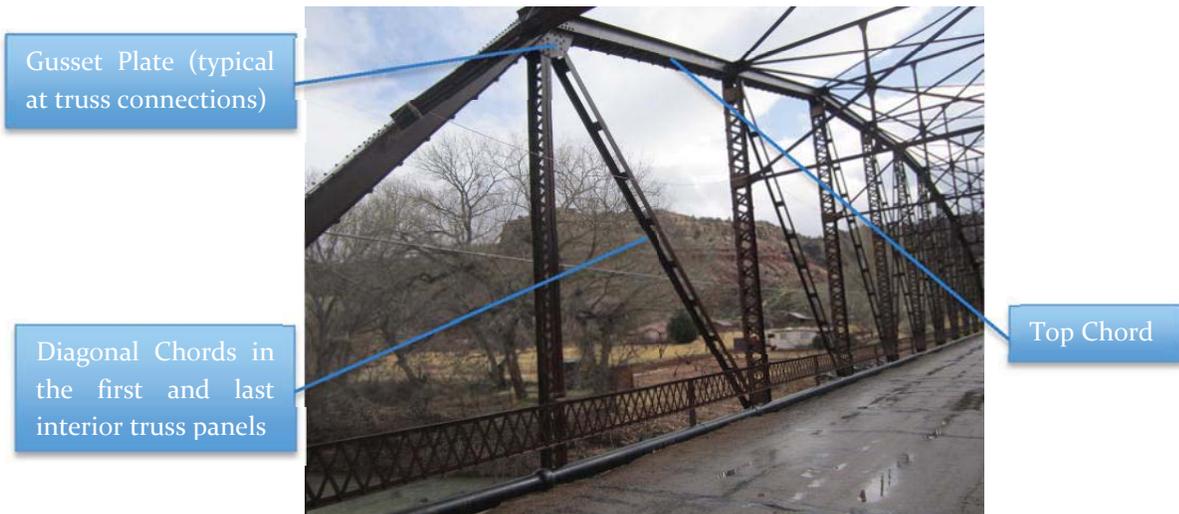
FIGURE 2 - TRUSS MEMBERS AND CONNECTIONS

The gusset plates and rivets that connect to the limiting truss members were analyzed and determined to not control the load rating. Gusset plates are plates that connect the truss members (see Figure 2). The analysis was done according to the 2014 Interim Revisions to the AASHTO Manual for Bridge Evaluation.

The expansion bearings on the north abutment are locked up due to debris and deformation. The resulting change in stress had not been captured previously. The analysis determined that the most significant effect is that during extreme temperatures there is a significant increase in compressive and tensile stresses in the top and bottom chords, respectively, which were likely not intended in the original design. By replacing these bearings, the bridge performance will be restored to the proper function. These increases in stress have minimal effect on the diagonal chords. See Figures 1 and 2 for identification of truss chord members.

The diagonal chords in the first interior truss panels will need to be stiffened for improved resistance to compressive buckling. This applies to 4 diagonal chords. The recommended solution is to bolt plates to the double angles.

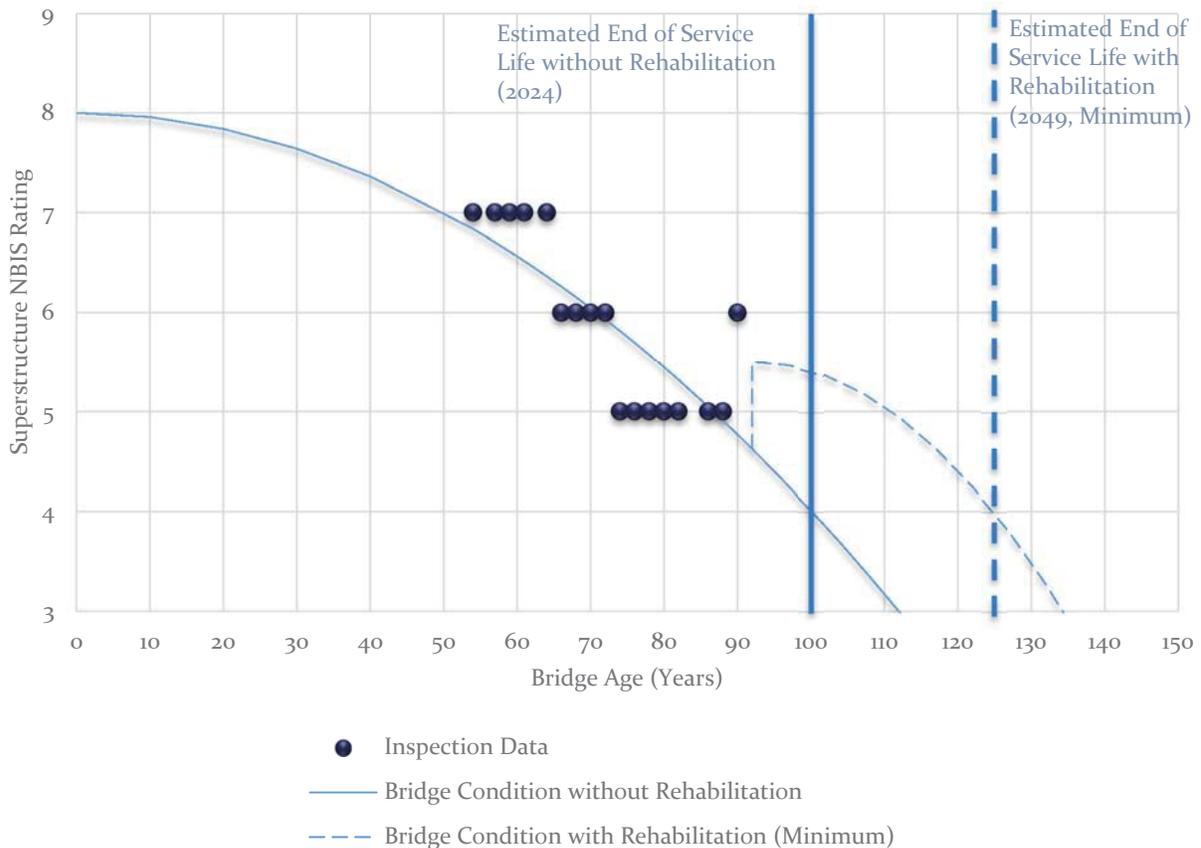
FIGURE 3 - BRIDGE CONDITION OVER TIME

Figure 3 shows the NBIS condition ratings of the bridge over time.

The estimated remaining service life was determined by establishing the probable end of service life using a data curve fit that follows the historical data and typical bridge performance. If no action is taken, the bridge condition will likely require replacement by 2024.

With the recommended improvements of stringer and deck surface replacement, floor beam and diagonal strengthening, bearing replacement, and bridge repainting, this bridge would be expected to perform for an additional 30 years (until 2049) at a 25-ton posting performance level. At that time, a re-evaluation with an expected maintenance action of repainting and deck surface repair would most likely provide an additional 25 years of service – moving the projected end of service life to 2074. These results are in keeping with the original rehabilitation alternative which assumed 30 additional years of service life from the time of construction.
